# Understanding obsolescence

## A holistic model for life cycle analyses of buildings

COST MINEA Odense workshop stocks 11-12/08/2016

André Thomsen

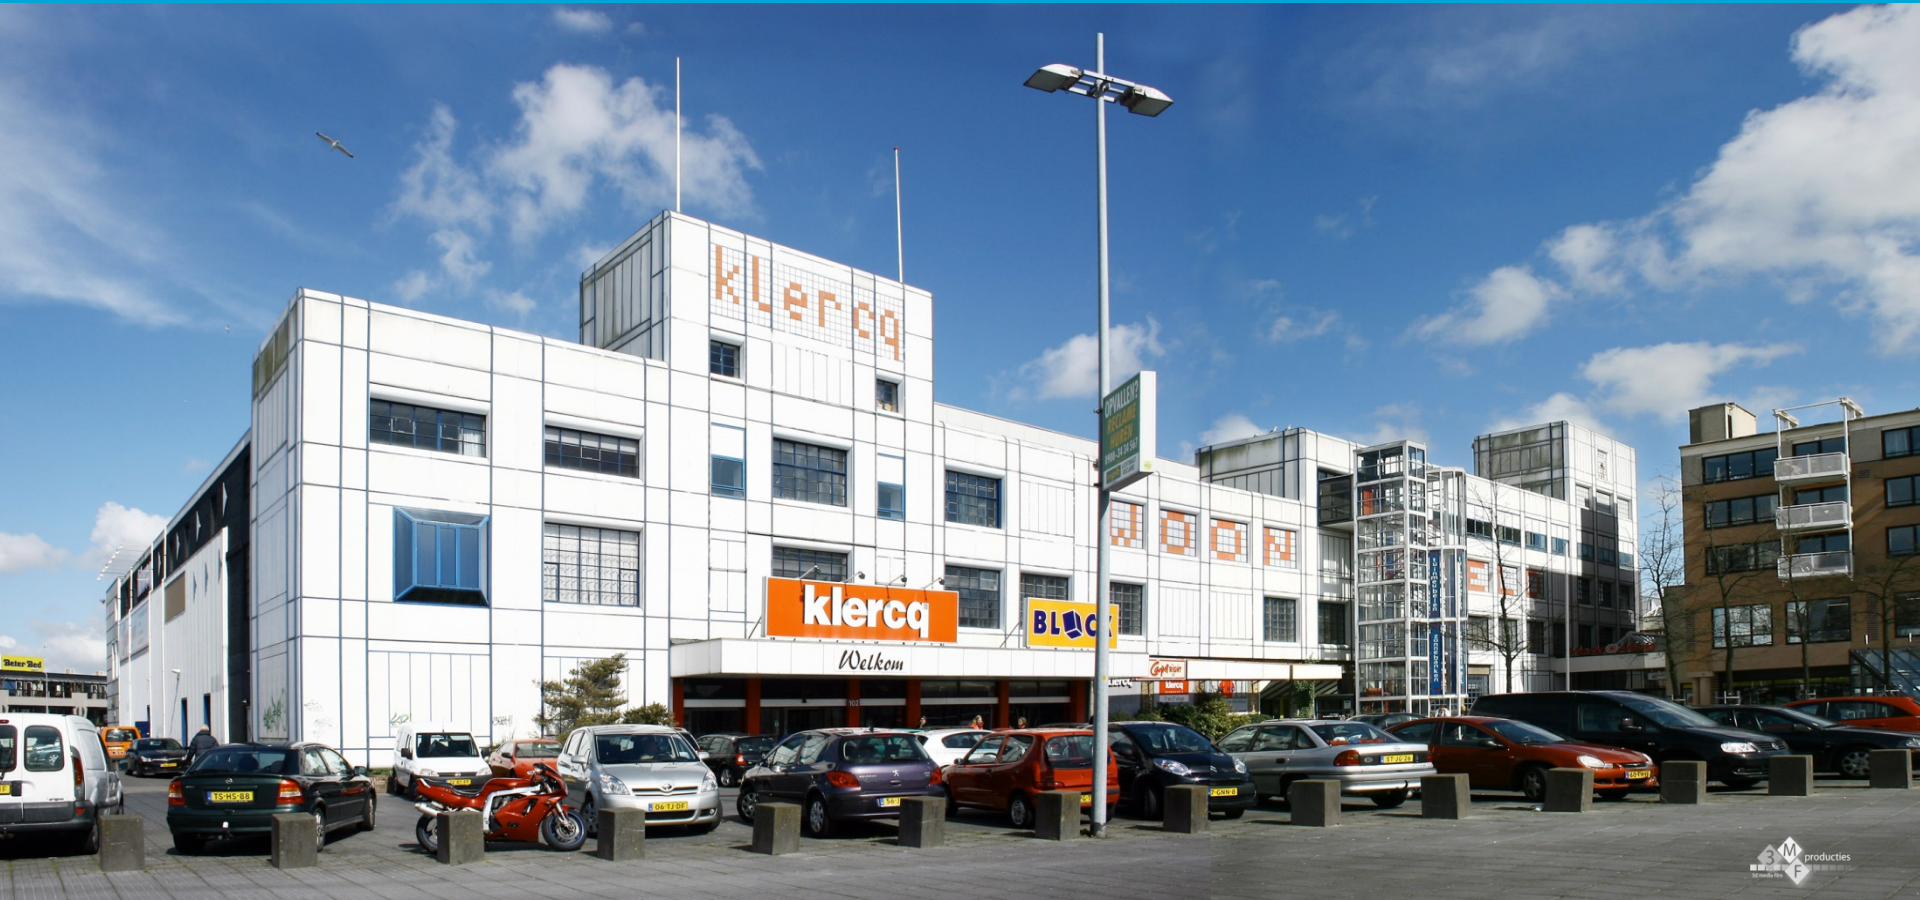
## Main life cycle phases:

I. Initial phase	1920-1940
II. Heyday phase	1940-1965
III. First decline	1965-1974
IV. Extended use phase	1974-2008
V. Second decline	2008-2013
VI. Redevelopment	2013-
